# Home Inspection Report

123 Main St, Anytown, WI 54000

Friday June 9, 2023

Ric Thompson  
N8490 Van Dyne Rd.  
Fond du Lac, WI 54937  
920-410-6682  
ric.thompson@acehomeinspectionswi.com

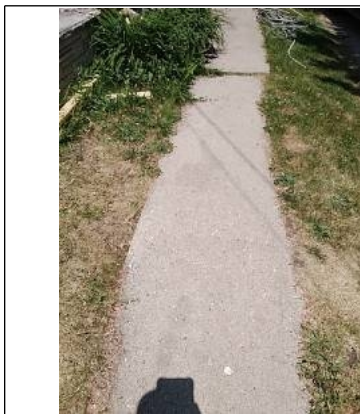
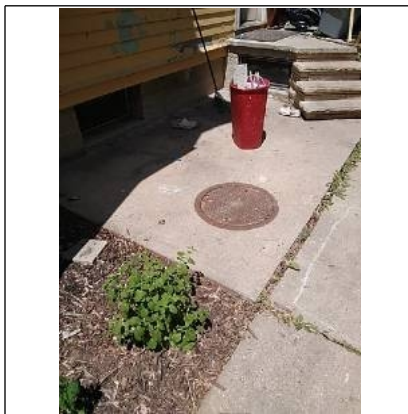
Walks had some settlement and pitched toward the house, recommend repair and/or replace

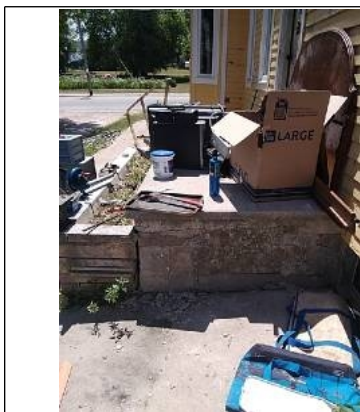
Recommend railing for steps - SAFETY CONCERN.  
 Step risers are uneven, may present a trip hazard. Recommend repair and/or replacement

Example of where a railing is recommended

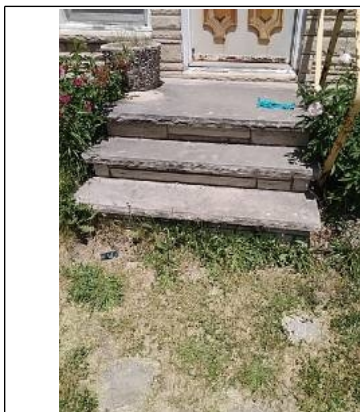
Front steps have uneven riser heights

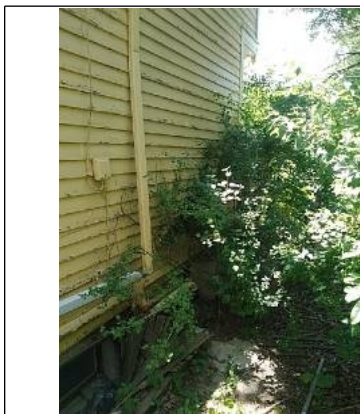
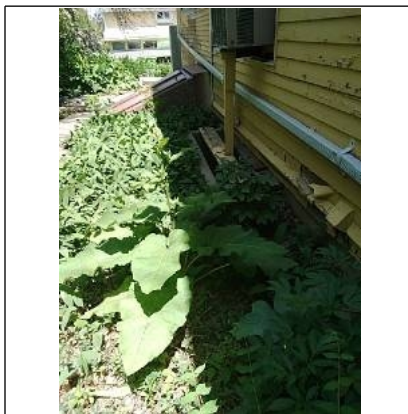
**Comments** Recommend trimming trees/vegetation so it doesn't come into contact with the home

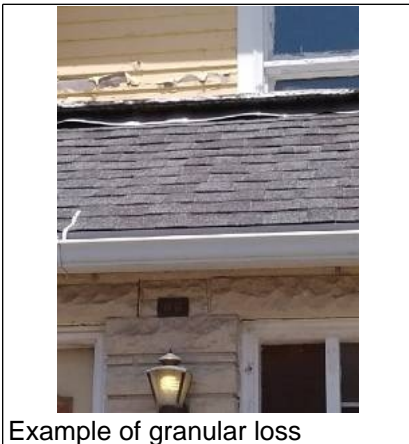
**Comments** Shingles have granular loss present indicating the shingles are nearing the end of their life. Recommend evaluation by a qualified professional for accurate life expectancy remaining,

Example of granular loss

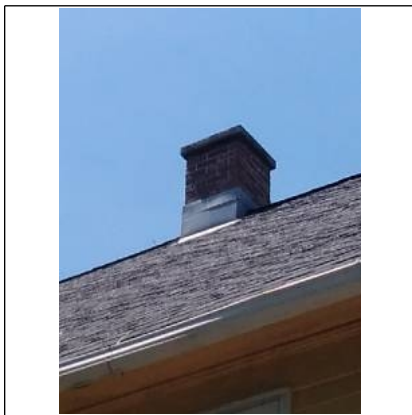
**Comments** Recommend installing rain cap/spark arrestor

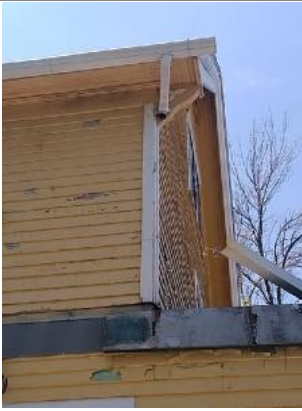
**Comments** Recommend adding downspout extensions to discharge away from the house. 5-6' extensions recommended.

Example of where downspouts and extensions are recommended

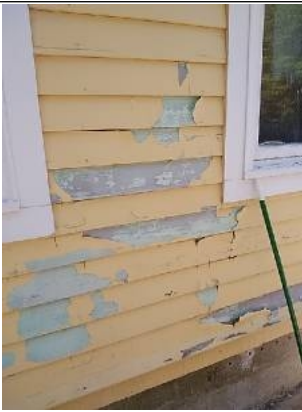
Siding was in need of normal painting / staining maintenance, recommend painting/staining

Example of peeling paint

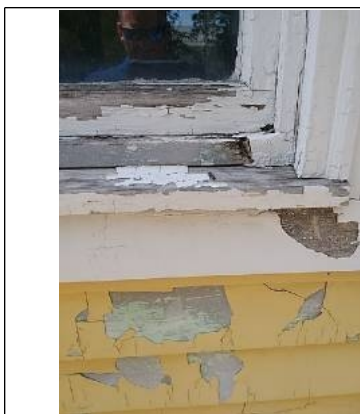
**Comments** Trim was in need of normal painting maintenance.  
 Some rotted trim boards recommend repair/replacing damaged sections

Example of wood rot

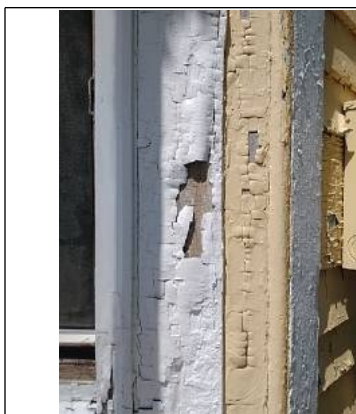
Example of trim needing paint

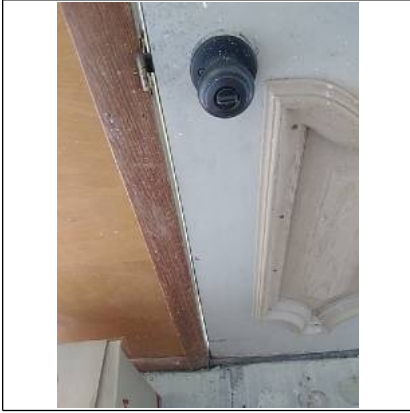
**Comments** Exterior-Daylight is visible around the front door. Recommend repair.

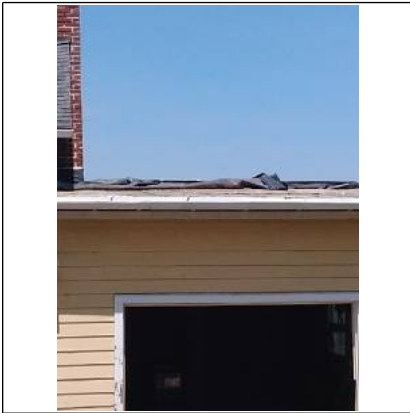
Garage-Portions of the roof covering are missing. Recommend repair.

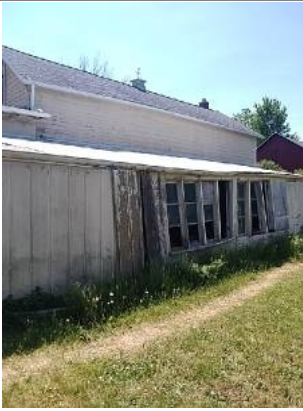
Garage-Gutters are improperly pitched. Recommend repair.

Example of improperly pitched gutters

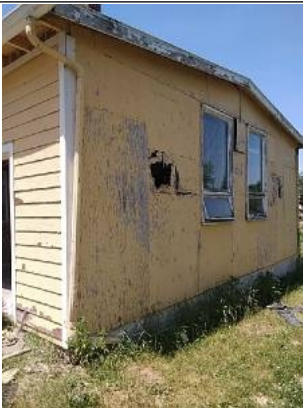
Siding had some damage recommend repair

Example of damaged siding

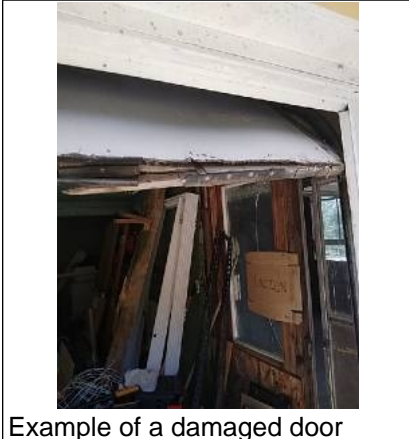
**Comments** Garage door was damaged, recommend repair

Example of a damaged door

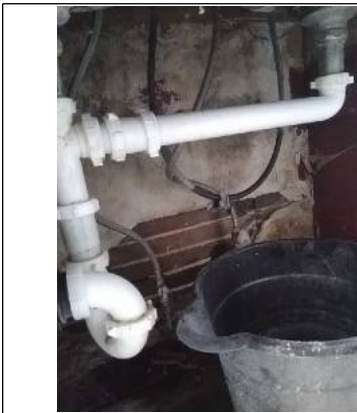
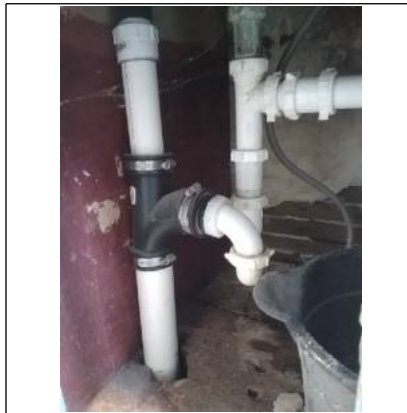
**Comments** Kitchen-Faucet is not secured. Recommend repair.

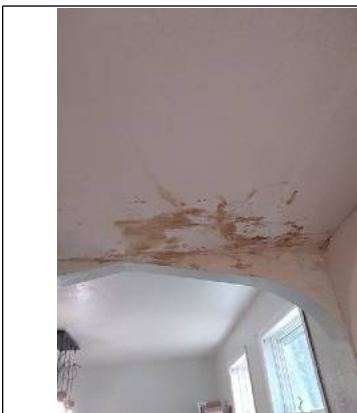
**Comments** Kitchen-Moisture staining is present on the ceiling. Recommend further evaluation.

Moisture staining is present on the ceiling

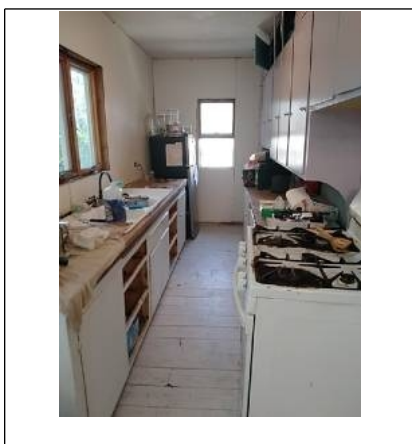
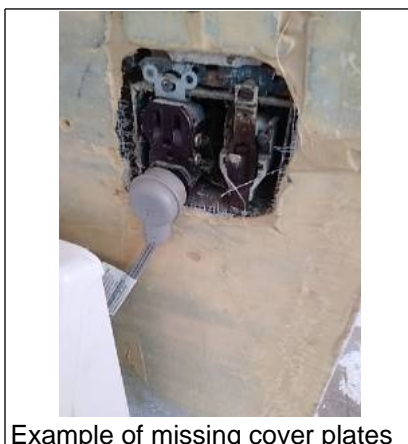
Example of missing cover plates

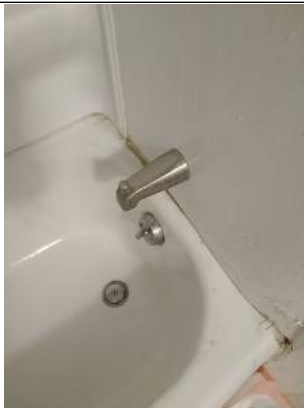
**Comments** Bathroom 1-Tub and shower fixtures are not secured. Recommend repair.

Nozzle is not secured

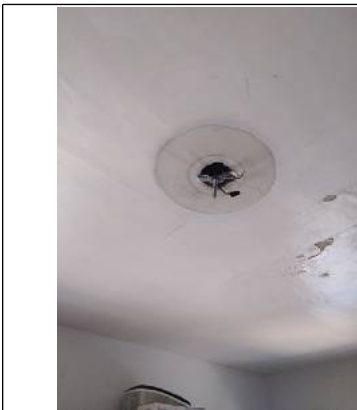
Open electrical termination

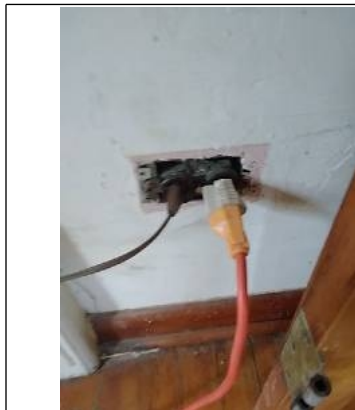
Missing cover plate

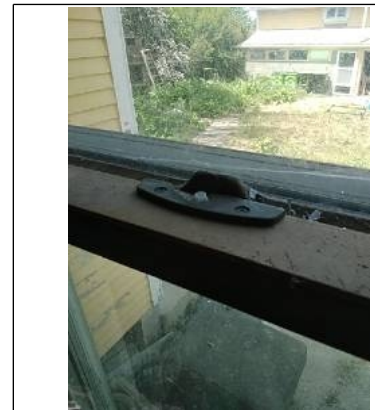
Missing window hardware

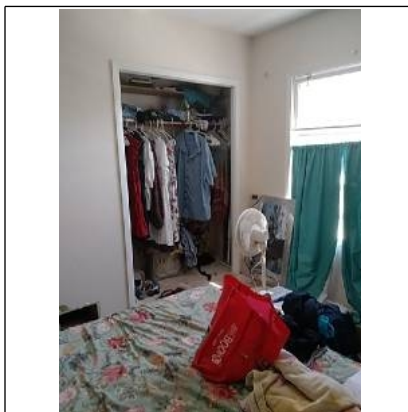
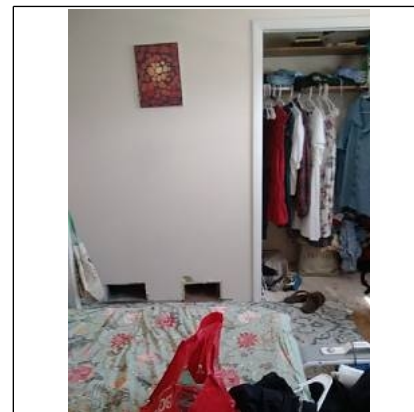
Open electrical junction

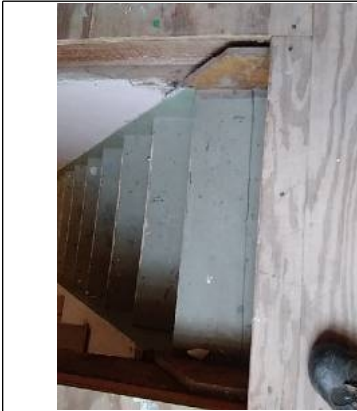
Cracked stair tread

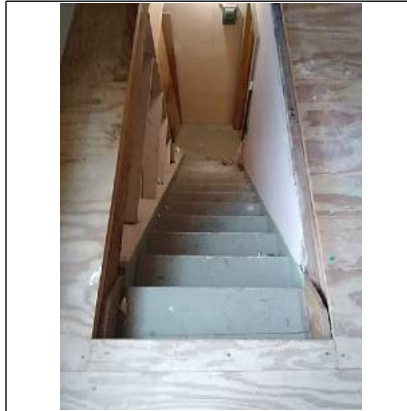
☐ None  
**Condition** ☐ Satisfactory ☒ Marginal ☐ Poor ☐ Loose/Missing  
**Handrail** ☐ Satisfactory ☒ Marginal ☐ Poor ☐ Safety hazard ☒ Hand Rail/Railing/Balusters recommended  
**Risers/Treads** ☐ Satisfactory ☒ Marginal ☐ Poor ☐ Risers/Treads uneven ☐ Trip hazard  
**Comments** Interior-Top attic step has a cracked tread. Recommend repair.  
 Interior-Recommend installing a handrail on the attic stairs.

Recommend installing a handrail

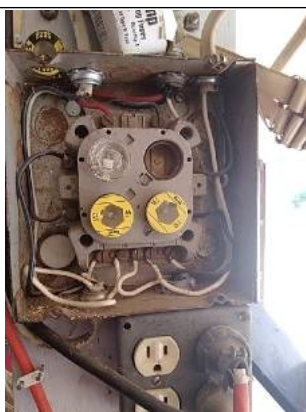
Sub panel 2-Missing fuse
