# Home Inspection Report

123 Main St, Anytown, WI 54000

Friday June 9, 2023

Ric Thompson  
N8490 Van Dyne Rd.  
Fond du Lac, WI 54937  
920-410-6682  
ric.thompson@acehomeinspectionswi.com

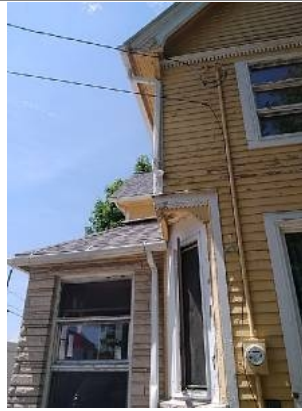
Example of where downspouts and extensions are recommended

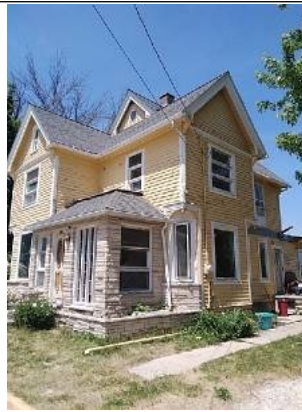
Example of peeling paint

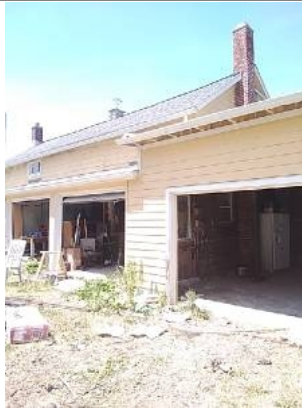
Example of improperly pitched gutters

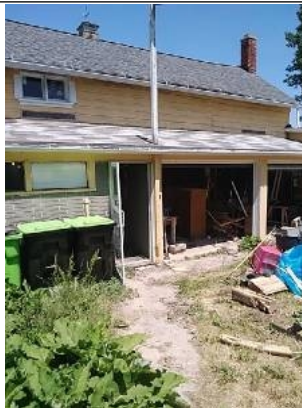
Example of damaged siding

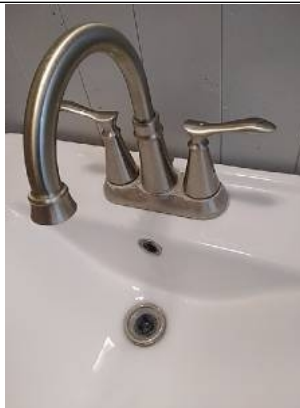
Nozzle is not secured

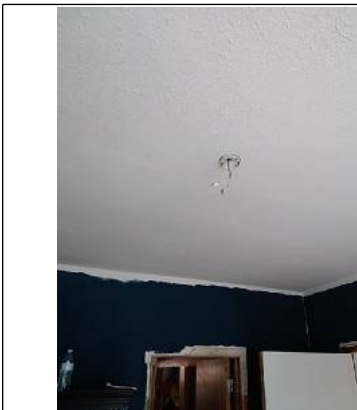
- 12) Home has open gound receptacles present.
- 13) Home has rooms where lights are not installed leaving unprotected electrical terminations.
- 14) Recommend replacing the missing cover plates throughout the home.

Open electrical termination

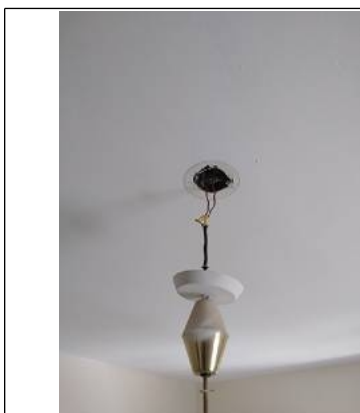
Open electrical junction

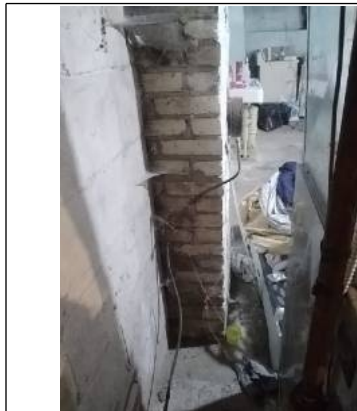
**Comments** Oil tank is not in use.

Capped oil line

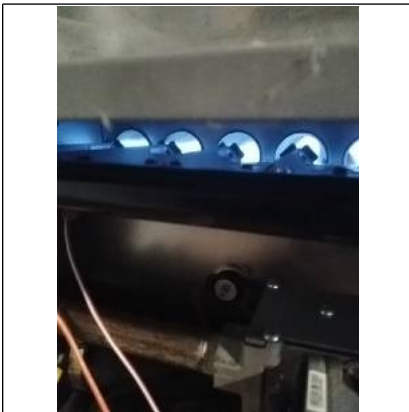
Operating furnace

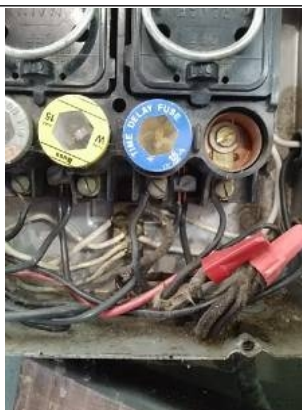
Double tapped circuits

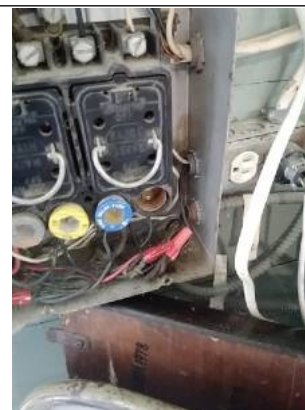
Open fuse slot

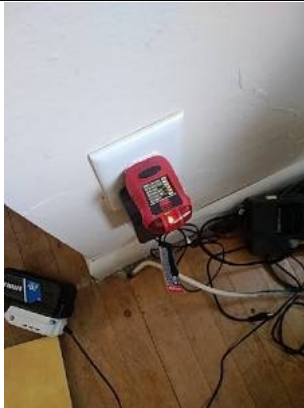
Example of open ground receptacles

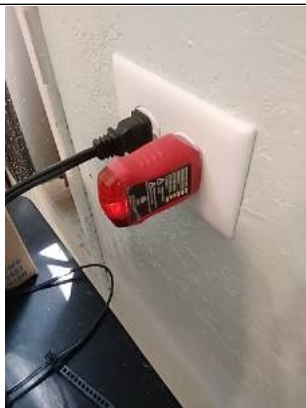
**Comments** Open ground receptacles are present

Example of open ground receptacles
